Making a 170° Thermostat for my '99 Corvette

This project began because the stock thermostat didn't allow for a low enough temps to re-program the fans without them coming on too often or for too long. I couldn't find a 170° thermostat, thought 160° was too cool, and wasn't ready to pay over \$50 for a thermostat that should sell for \$20. I also wanted a thermostat that would stay in all year around.

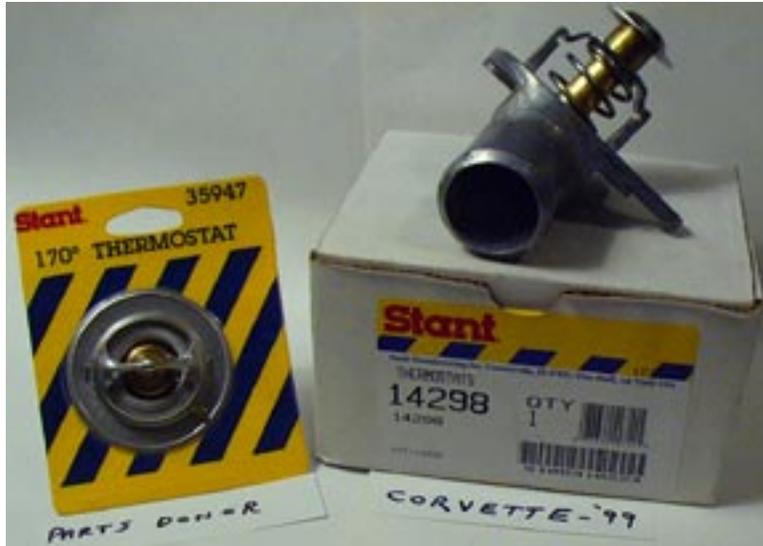
I started with a thermostat & housing to modify and a thermostat to be used as a parts donor. Both of these were purchased at PEP Boys. The original factory thermostat & housing was kept intact in case something went wrong or as a back-up/spare if needed. The original Corvette and the PEP boys STANT are almost identical with only some casting differences. Stant's web site list them as a supplier to GM. I had called Stant to ask them to rebuild my thermostat as a 170°, sell me the parts to make one or identify what parts I could use from another thermostat to make a 170° and they would do nothing. A trip to PEP boys followed, eyeballing their stock resulted in these choices.

Corvette replacement was p/n #14298 (\$30)

Donor thermostat was p/n #35947.... (\$19)

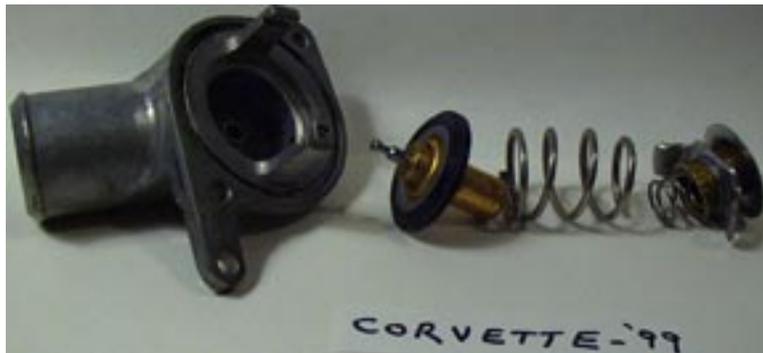
First, the Corvette thermostat was disassembled by slipping the bridge piece out from the two cast prongs. On my large spring one coil was removed (with dremel) to allow me to pry the end of the spring overtop of the bridge and rotate the spring so it would coil on top of the bridge. This relieved enough tension to enable me to push down on the bridge (with pliers and hand) and rotate it to disengage it from the prongs. This part and the reassembly were the hardest part of the mod.

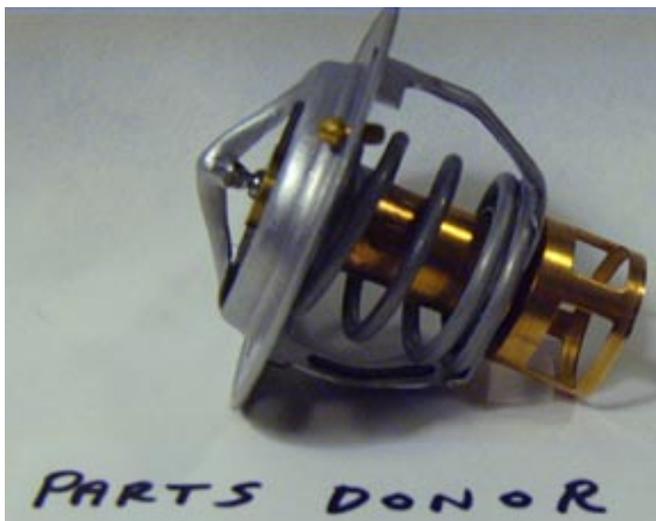
This is the parts donor. The internal gold part is what is needed and must be removed without damage. The large spring and gray housing are not needed. I have no idea what car it fits.

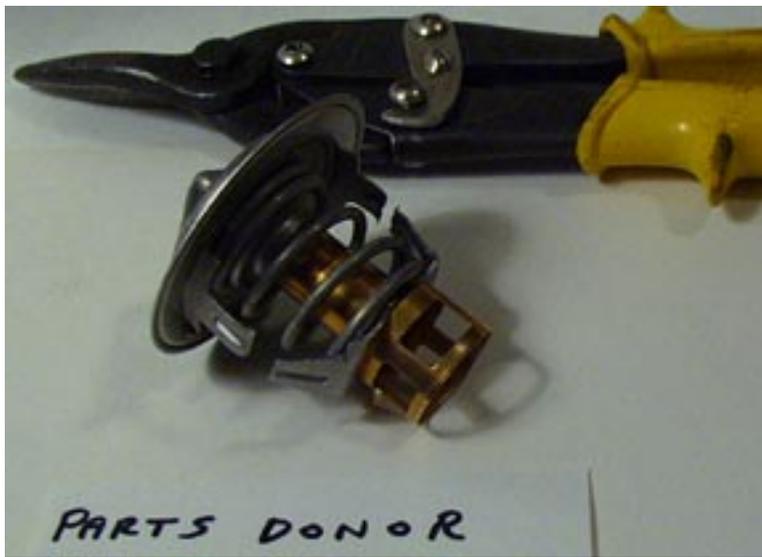
The bridge on this one does not disassemble like the Vette thermostat so the cutting began.

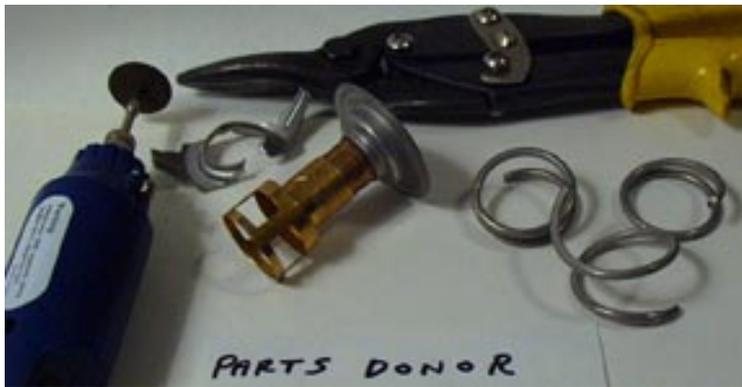
Next, the spring took two cuts so the bridge would drop down and then that got cut that too. Then two pliers were used to pull the bridge apart and remove it as shown; then the spring coils just slipped off. Care was used not to bend the diaphragm or cut or damage the gold parts

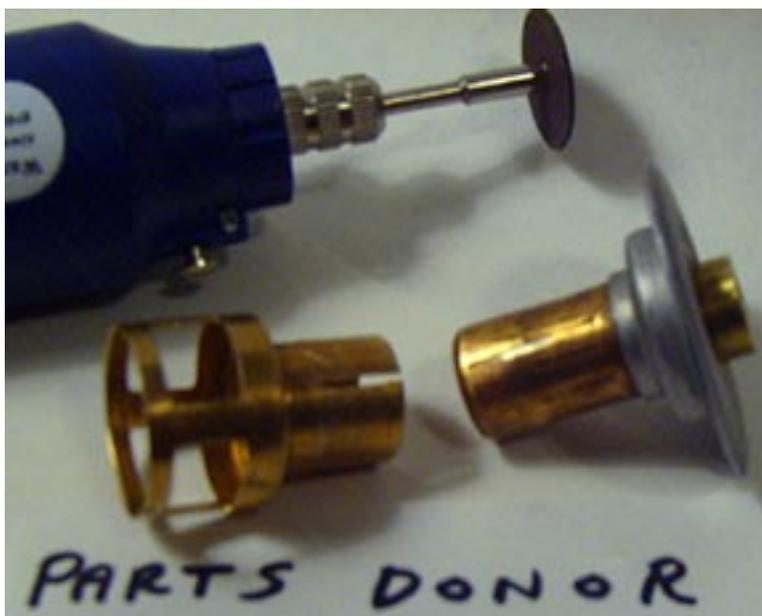
This is the most delicate part, great care is used not to damage the part that is to be used (on the right). To separate these two parts you must dremel a slit into the part on the left so it will relieve its grip (with a little help) on the rest of the thermostat. If you look carefully you will notice that the cut scored the part on the right but it is still good. I should have stopped just a little earlier but it is difficult to tell visually when you are through the outer sleeve. NEXT TIME, I'LL BE MORE CAREFUL.

The part on the right is the heart of the thermostat. This is the part that actually OPENS the diaphragm. There is a stainless steel pin that fits in the top; when heated up, it pushes the pin out and that pushes the diaphragm away from its seat. The big spring only provides closing pressure.

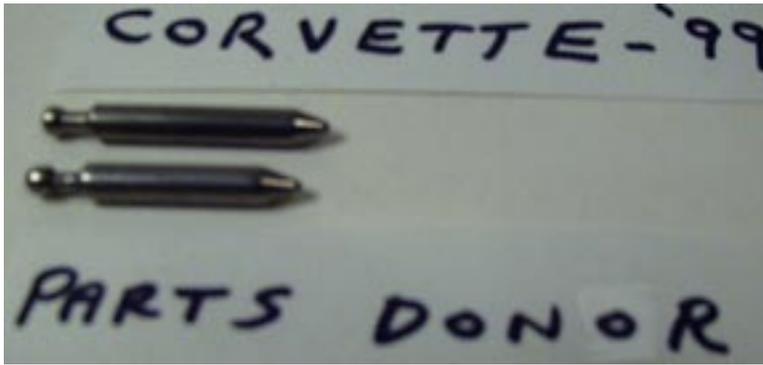
Both pins are from the top part of the thermostats. The longer one is used when re-assembling the thermostat. They are both the same diameter. When inserted, it feels like its pushing back a little from air compression. Do not worry about it, just keep going, it will settle in all the way later.

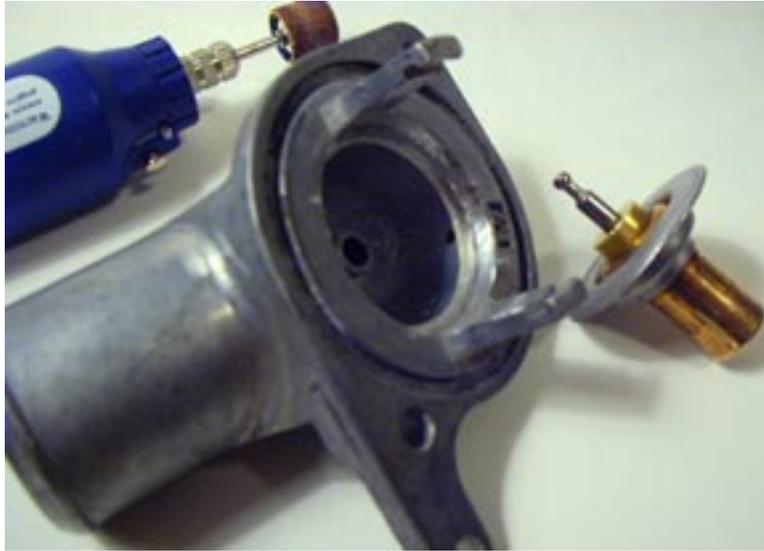
At this point I wanted to make sure the diaphragm and housing work together without binding. This combination did NOT. Filing away about $\frac{1}{64}$ th of an inch around the diaphragm, then smoothing out some of the first lip (verticle part only) of the housing opening so the diaphragm could move freely away from the seat was the answer. CARE WAS USED NOT TO HIT THE SEAT PART OF THE HOUSING. The fit was tested by pushing the diaphragm in with moderate force and to see if it binds in any way; if so, more filing was used so it will not bind while in during operation. When done, it will move in/out easily without any bind. The edges were smoothed to eliminate any sharpness that could dig into the housing and cause a bind. A minute amount of side play could be felt when the final fit was acheived.

The rubber seal around the Corvette diaphragm was not used because it could not be removed without damage.

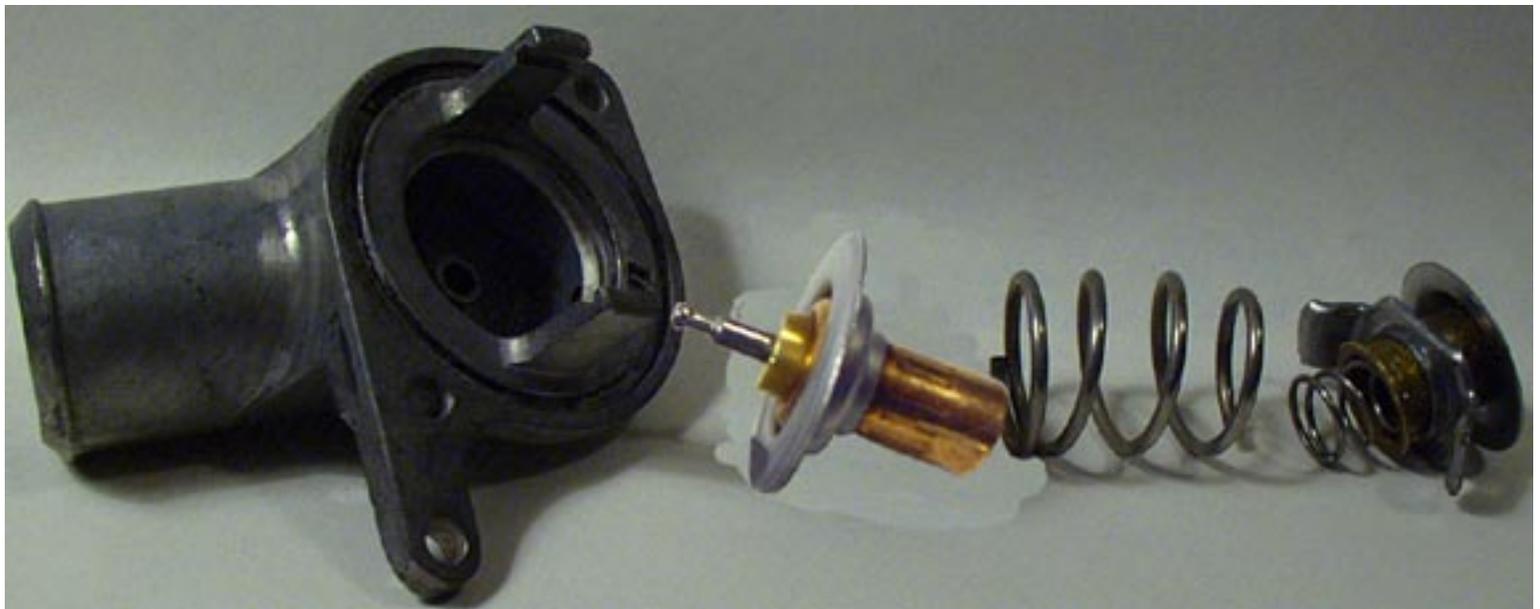
The thermostat is now ready to assemble. Notice that it looks just like the dissambled Corvette thermostat in the 2nd picture except you have removed the Corvette Diaphragm (with rubber seal around the edge) and replaced it with the donor thermostat diaphragm(170°).

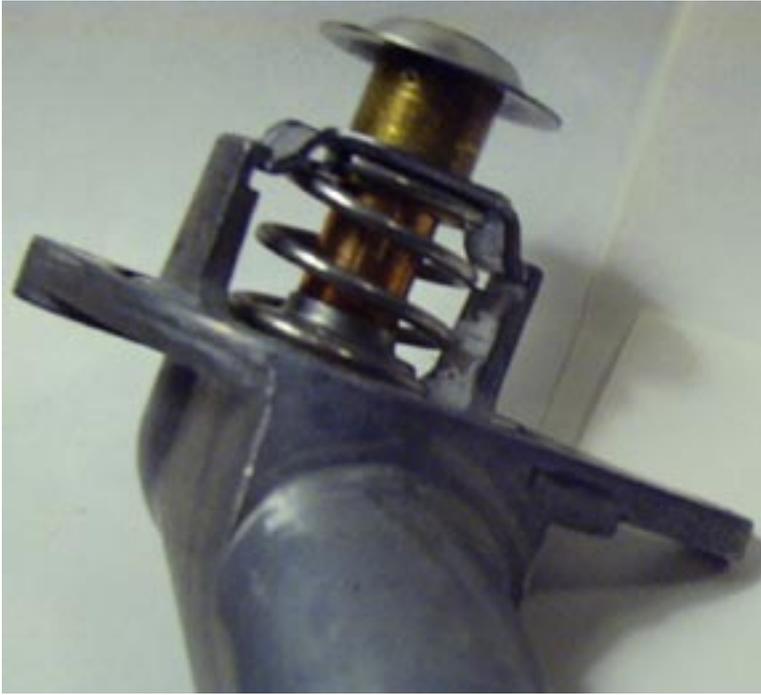
Looking back at the second picture reminded me there is a second smaller spring inside the gold part: I made sure I didn't forget to put it back. Putting the end of the top of the big spring overtop of the bridge and rotating it to get two full coils above the bridge (but under the shiny cap) lessened the tension. I got the bridge into the notches to seat it then rotated the spring (with pliers) so that it was all coiled back under the bridge as you see it on the left here. When all done that shiny cap should push in and spring back from the tension of the little spring inside the gold part.

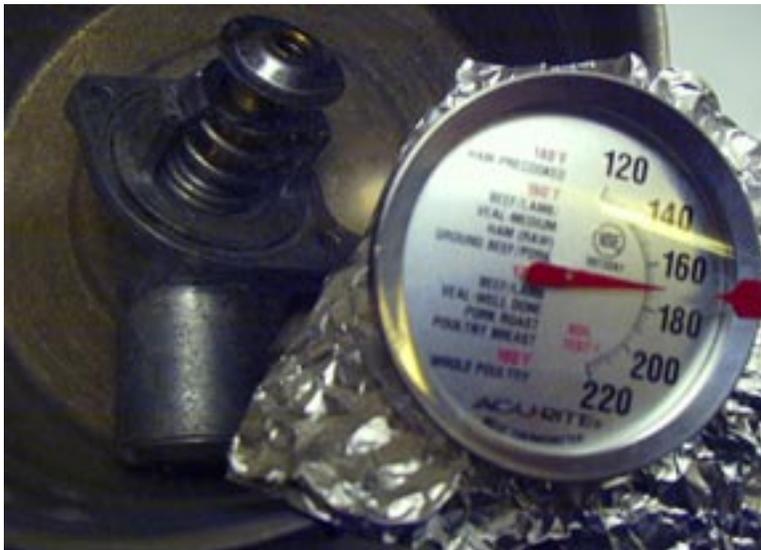
The next thing was to test it to make sure it opens and closes O.K. A meat thermometer and an old pan filled with water was used. The foil underneath the gauge is just to keep heat off the underside of the gauge and to prevent it from falling into the pan. It also makes it easier to pick up the gauge. At 170° you could not see it open yet. By 180° you could detect it starting to open and by 190° its open and by 200° that's all it can open. I did not let this worry me. I WATCHED IT CLOSE AND NOTED THE TEMPS. I could see that at 180° it is still open a little and that is where it will be at cruising speed on a nice warm day. Even though this is a 170° thermostat that doesn't mean the car will cruise at that temp, that only means that the thermostat begins to push open at 170°, after that it's a balancing act. I have found most cars cruise at 11 or 12 degrees over the temperature rating of the thermostat. With my modded thermostat in my stock C5/A4, I cruised at 181° with an outside temp of 70° while doing 70 mph. Up the speed to 80+ mph and my stat bounces between 183° & 185°. When you turn up the speed or outside temp, it'll climb a little higher. Throw in some

stop & go traffic and temps are going to work their way to over 200° unless you can get a little non-stop movement to bring them down again. If these temps were not low enough for me, a 160° thermostat could be installed and the cruising temps would be about 10 degrees cooler. My C4 with a 160° thermostat cruised at 172° or 173° most of the time. If you want to control how high the engine temps will go, fan re-programming must be performed to make the fans come on at a lower temp to hold the heat down. The lower thermostat just gives you a lower cruising temp and provides a little more cushioning room before you break into the 200° ranges.
